# Inspection Report

**Property Address:**  
123 Suburbs Lane  
Austin TX 78702

**Austin Home Inspection**

# PROPERTY INSPECTION REPORT

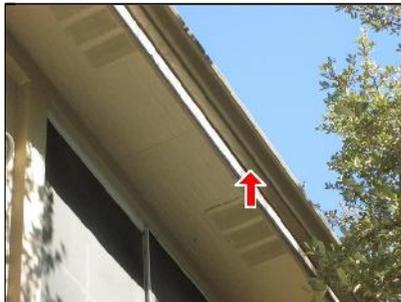
B. Item 1(Picture)

(1) The gutter at the rear of the home is loose. Damaged gutters will not be as effective in controlling rain run-off from the roof. I recommend repair as needed.

(1) The gutter at the rear of the home is loose. Damaged gutters will not be as effective in controlling rain run-off from the roof. I recommend repair as needed.
-

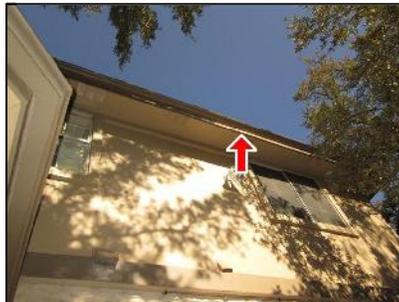
B. Item 2(Picture)

(2) The gutters are full of debris in most areas around the home and need to be cleaned. The debris in gutters can also conceal rust, deterioration, or leaks that are not visible until cleaned, and I am unable to

determine if such conditions exist.

(2) The gutters are full of debris in most areas around the home and need to be cleaned. The debris in gutters can also conceal rust, deterioration, or leaks that are not visible until cleaned, and I am unable to determine if such conditions exist.
-

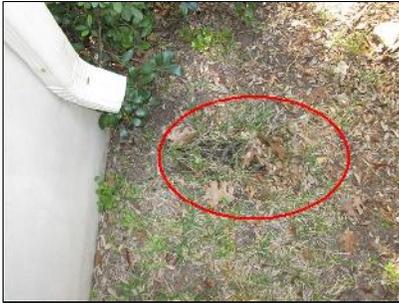
B. Item 3(Picture)

(3) The downspout at the rear of the home is missing the downspout splash block. Erosion can continue or become worse if not corrected.

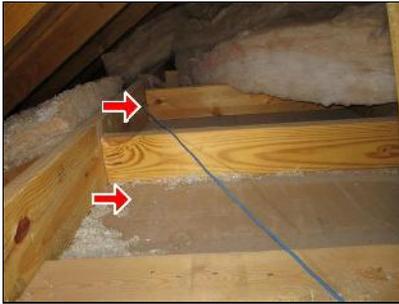
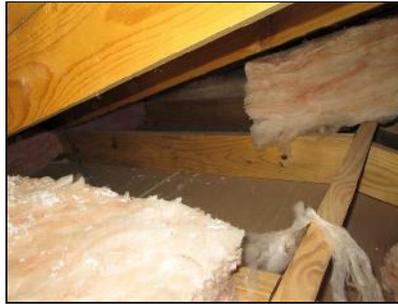
Some batt insulation in the attic has been displaced. This diminishes the ability of the insulation to perform as intended. This condition will cause heating and cooling costs to be much higher than necessary. I recommend adding new insulation in the attic to a minimum of R-30 or better.

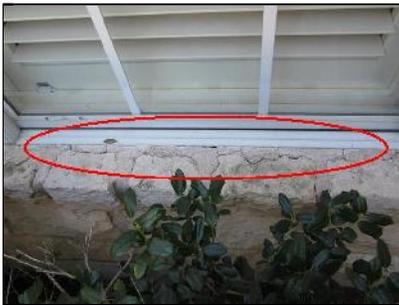
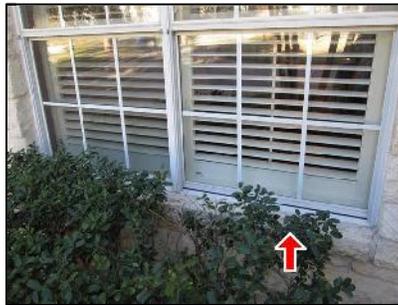
(1) The rock veneer around the window frames at the front of the home is missing caulk. This could allow moisture penetration and cause damage to surrounding material. I recommend the exterior sill be sealed around the window frames.

(1) The rock veneer around the window frames at the front of the home is missing caulk. This could allow moisture penetration and cause damage to surrounding material. I recommend the exterior sill be sealed around the window frames.
-

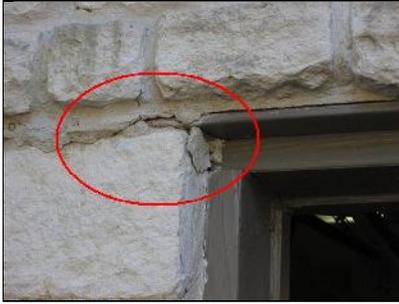
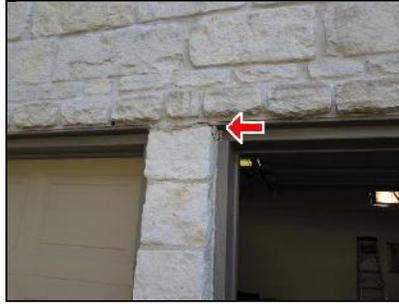
(2) The rock veneer at the garage door is not sealed around the door frame. Moisture penetration can occur causing deterioration of surround material.

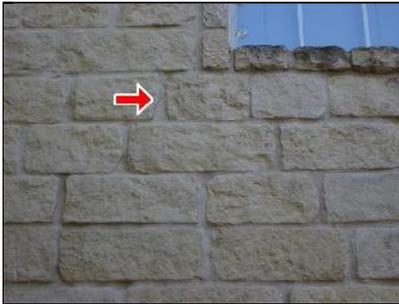
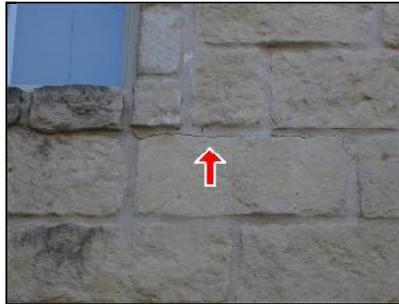
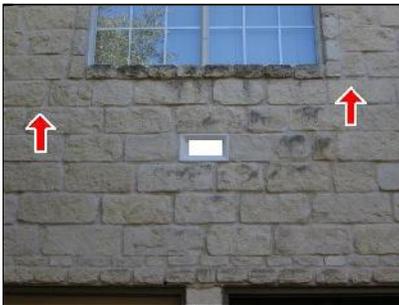
(3) The rock veneer above the garage door has cracking mortar. These cracks can be repaired by a process called tuck-pointing.

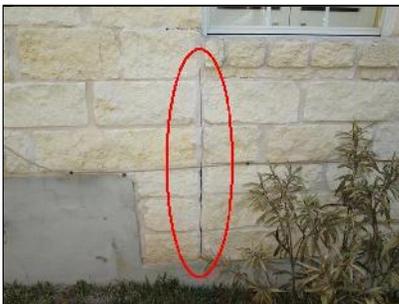
E. Item 8(Picture)

(4) The rock veneer on the south side of the home is missing caulking in the expansion joint. Moisture penetration will occur, causing deterioration of the material if not corrected.

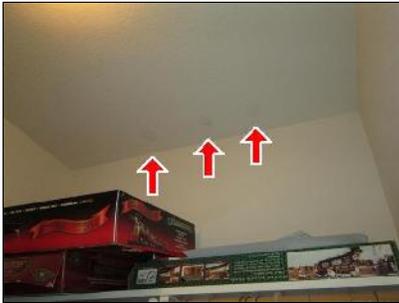
F. Item 1(Picture)

The sheetrock on the ceiling in the downstairs half bath closet reveals a light stain that appears to be from a water leak. The moisture meter was used, and it did not indicate an active leak.

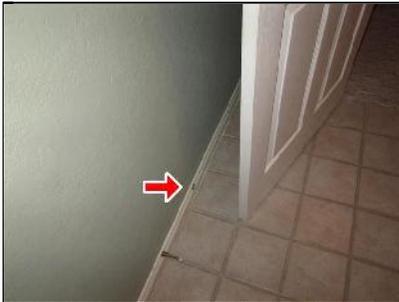
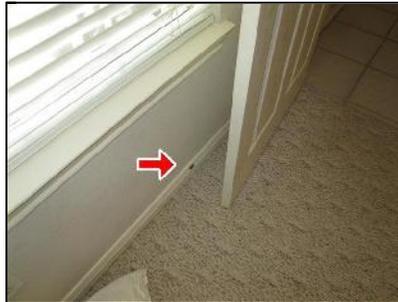
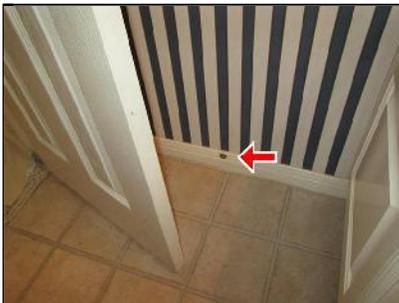
The door at the at various locations around the house are missing the doorstops. Damage to the door or wall can occur without a proper doorstop.

- The privacy door at downstairs half bath.
- The privacy door at the downstairs bedroom.
- The privacy door at the downstairs full bath.

The door at the at various locations around the house are missing the doorstops. Damage to the door or wall can occur without a proper doorstop.
  - The privacy door at downstairs half bath.
  - The privacy door at the downstairs bedroom.
  - The privacy door at the downstairs full bath.

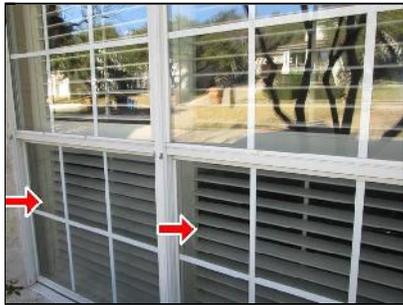
H. Item 1(Picture)

(1) The windows at all locations around the home are missing screens. It is common to remove window screens during the listing of a home. I am unable to determine if any screens are missing or damaged. I recommend having the screens replaced.

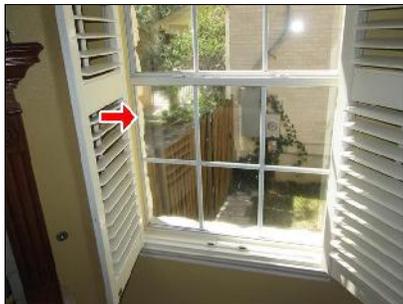
H. Item 2(Picture)

🏠 (2) The southeast window in living area appears cloudy (lost seal). This can cause some heat loss in winter and loss of cool air in summer if not corrected. In order to correct the cloudy appearance of glass, a replacement of the glass pane or unit will be necessary.

(2) The southeast window in living area appears cloudy (lost seal). This can cause some heat loss in winter and loss of cool air in summer if not corrected. In order to correct the cloudy appearance of glass, a replacement of the glass pane or unit will be necessary.
-

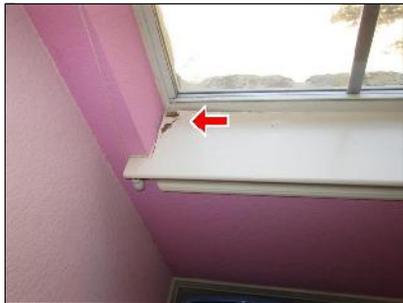
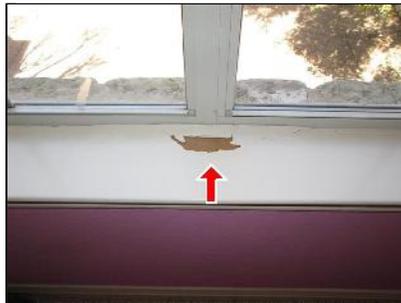
🏠 (3) The window sill in the upstairs north bedroom has peeling paint and is swollen. This damage is generally caused by condensation that builds up on the aluminum window frames during cold weather.

(3) The window sill in the upstairs north bedroom has peeling paint and is swollen. This damage is generally caused by condensation that builds up on the aluminum window frames during cold weather.
-

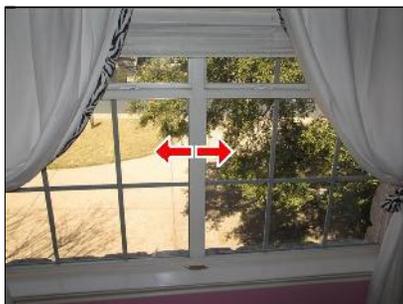
H. Item 5(Picture)

🏠 (4) The lower windows in upstairs northwest bedroom appears cloudy (lost seal). This can cause some heat loss in winter and loss of cool air in summer if not corrected. In order to correct the cloudy appearance of glass, a replacement of the glass pane or unit will be necessary.

(4) The lower windows in upstairs northwest bedroom appears cloudy (lost seal). This can cause some heat loss in winter and loss of cool air in summer if not corrected. In order to correct the cloudy appearance of glass, a replacement of the glass pane or unit will be necessary.

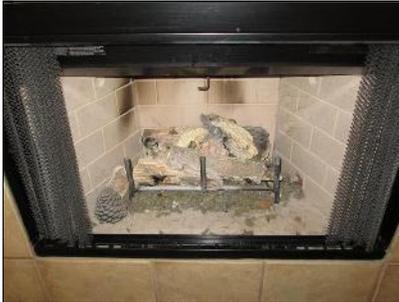
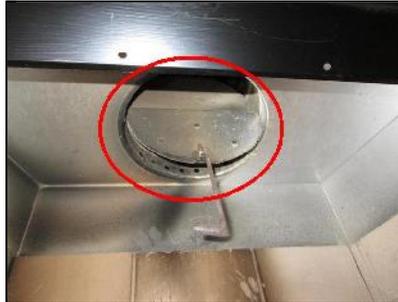
The damper for the fireplace in the living room is missing a clamp or lock that forces the lid to stay open (required for vented gas/LP logs). Without a clamp to force open the damper, it could shut and cause unsafe carbon dioxide to enter into the living space. A qualified person should inspect and repair as needed.

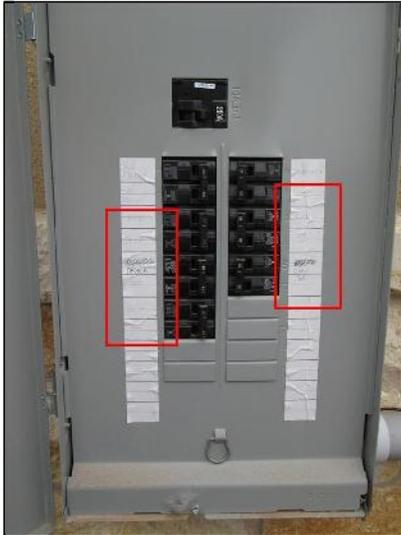
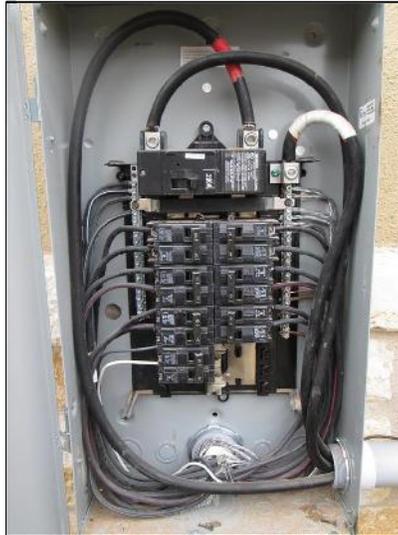
(2) The box is clean and in order but lacks properly labeling. Some labels are present, but are illegible or confusing. I recommend correcting for safety reasons.

(2) The box is clean and in order but lacks properly labeling. Some labels are present, but are illegible or confusing. I recommend correcting for safety reasons.
-

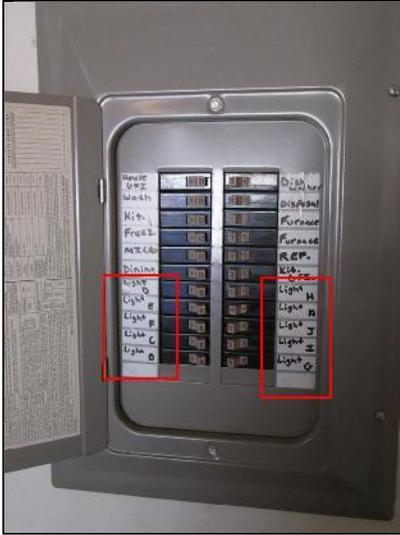
A. Item 3(Picture)

(3) The panel circuits are not properly labeled. I recommend labeling the circuits as needed.

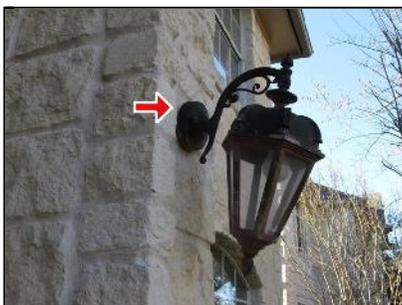
B. Item 1(Picture)

(1) The light fixture at the front of the home is loose and is not sealed around the base. This will allow moisture and insects into the electrical box behind the fixture. I recommend repair as needed.

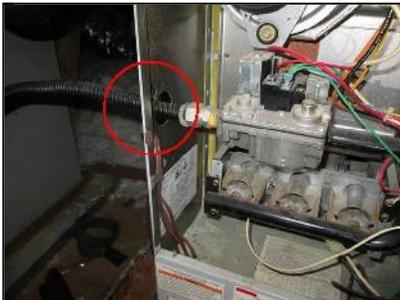
A. Item 3(Picture)

(2) The flex gas line at both furnace units was installed using thin wall flex tubing through the equipment housing instead of rigid pipe. This is not the recommended method of connection because of the potential for mechanical damage to the flex gas line.

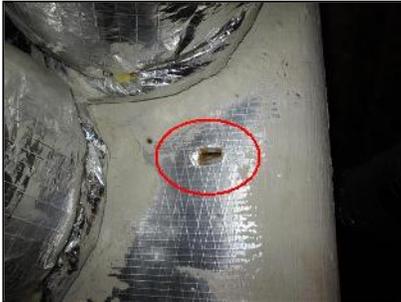
C. Item 1(Picture)

The plenum at the air handler in the attic is damaged and leaking conditioned air into the attic. Energy loss is occurring and the plenum should be properly sealed.

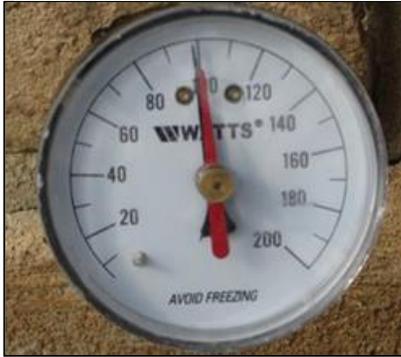
A. Item 1(Picture)

(1) Static water pressure on the house was 100 pounds/square inch. Pressure that is more than 80 pounds/square inch is considered excessive and could cause leaks to develop in the joints and valves of the plumbing system. I recommend installation of a regulator on the main water supply line to lower the static pressure on the house.

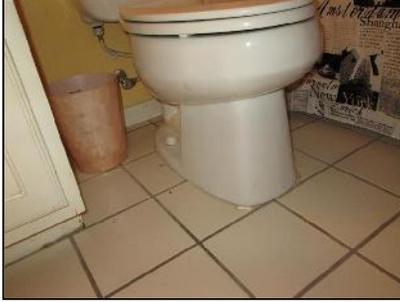
A. Item 2(Picture)

(2) The toilet in the upstairs hall bath is not sealed to the floor. Repairs are needed to prevent possible leak or seepage through crack or damaged area.

The toilet is also loose at the floor. Repairs may involve re-setting the toilet on a new wax seal. I recommend a qualified licensed plumber repair or correct as needed.

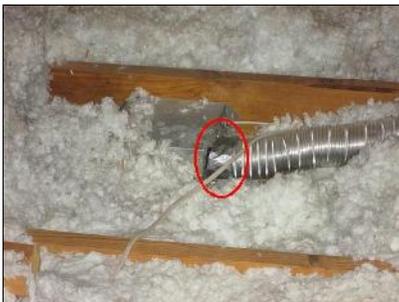
F. Item 1(Picture)

The exhaust fan duct for the upstairs hall bath has a damaged vent pipe in the attic. The vent pipe is loose and can allow moisture into the attic space that can lead to mold or cause condensation.

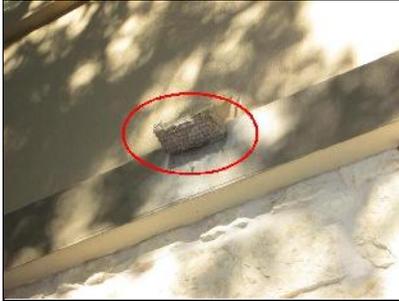
H. Item 1(Picture)

The dryer vent is a vertical vent terminating overhead. The vent at the wall is blocked by lint build-up and needs to be cleaned. Blocked dryer vents will affect the performance of the dryer appliance as well as pose a fire threat. I recommend having the vent cleaned before further use.

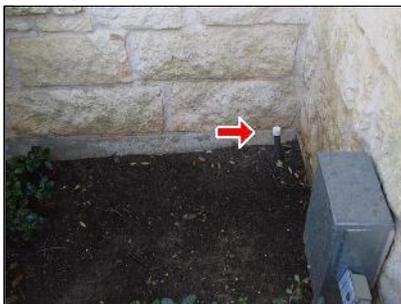
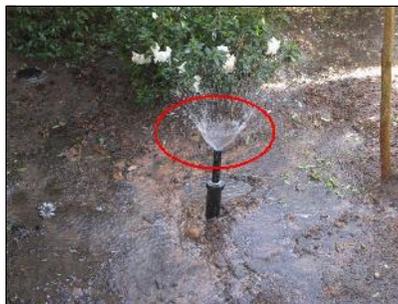
- 1 riser is missing a sprinkler head and is capped.
- 1 sprinkler head in the middle of the front bed is damaged and not functioning properly.

I recommend a qualified irrigation professional investigate further and repair as necessary.

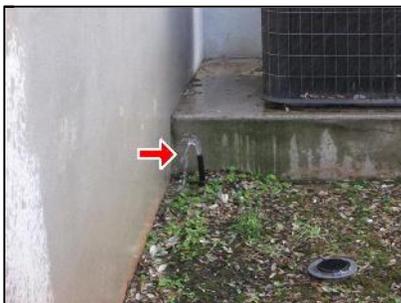
A. Item 4(Picture)

(4) Zone 2 services the north side yard and north portion of the backyard. 1 sprinkler head is broken and water is free flowing from the riser. I recommend a qualified irrigation professional investigate further and repair as necessary.
