# Inspection Report

**Property Address:**  
123 Suburbs Lane  
Austin TX 78702

**Austin Home Inspection**

# PROPERTY INSPECTION REPORT

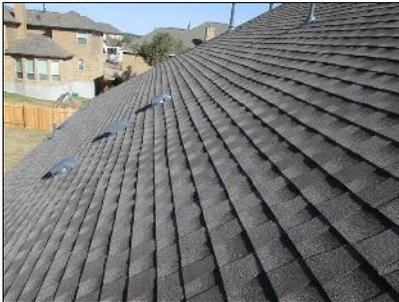
C. Item 1(Picture)

The roof covering is in good condition.

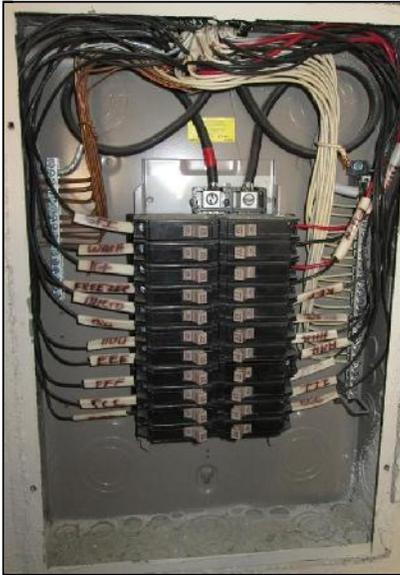
A. Item 4(Picture)

(4) The sub-panel box is located in the garage. The box is clean and in order.

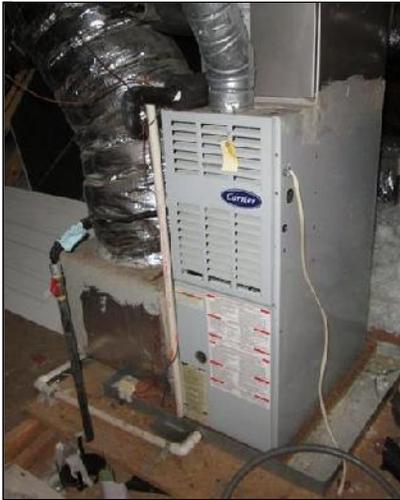
A. Item 1(Picture)

(1) The manufacture date on the furnace servicing the upstairs area is October 1996

Examination of the visible portions of the heat exchanger revealed a clean unit. The furnace is pilot-less and operated through the start-up sequence, ignition, run, and cool-down as expected.

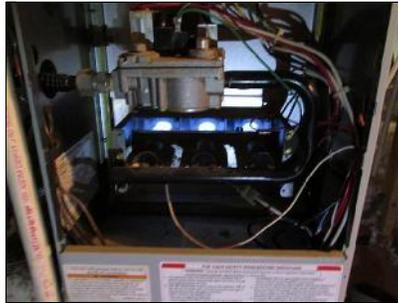
A. Item 2(Picture)

(2) The flex gas line at both furnace units was installed using thin wall flex tubing through the equipment housing instead of rigid pipe. This is not the recommended method of connection because of the potential for mechanical damage to the flex gas line.

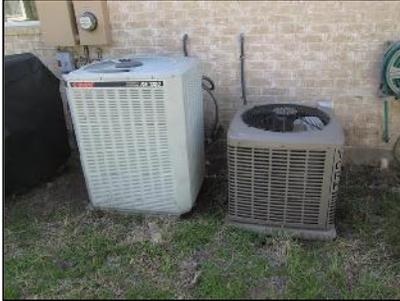
B. Item 1(Picture)

(1) The manufacture date for the Trane unit is November 1996.

The manufacture date for the York unit is March 2002.

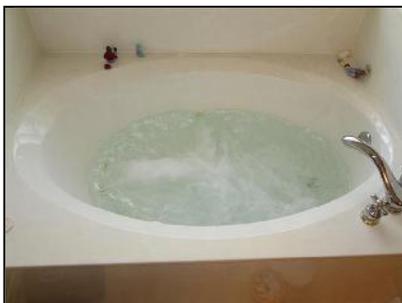
D. Item 1(Picture)

The whirlpool tub in the master bath operated as expected.

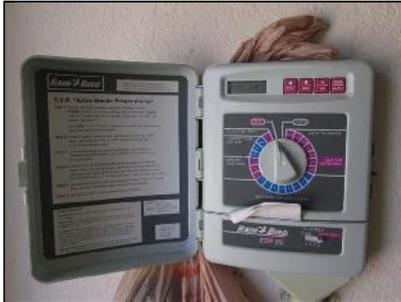
A. Item 1(Picture)

(1) The automatic sprinkler system is serviced by a Rain Bird controller. I was able to identify 3 working zones covering the front landscape beds, front grass, and north side yard.
